ONS-2017-064

September 20, 2017

Subject: Licensee Event Report 287/2017-001, Revision 0 - Unit 3 Reactor Protection System  
Actuation - Reactor Trip Due to Turbine Trip from Generator Lockout

1. FACILITY NAME Oconee Nuclear Station Unit 3					2. DOCKET NUMBER 5000287					3. PAGE 1 of 3		
4. TITLE Unit 3 Reactor Protection System Actuation - Reactor Trip due to Turbine Trip from Generator Lockout

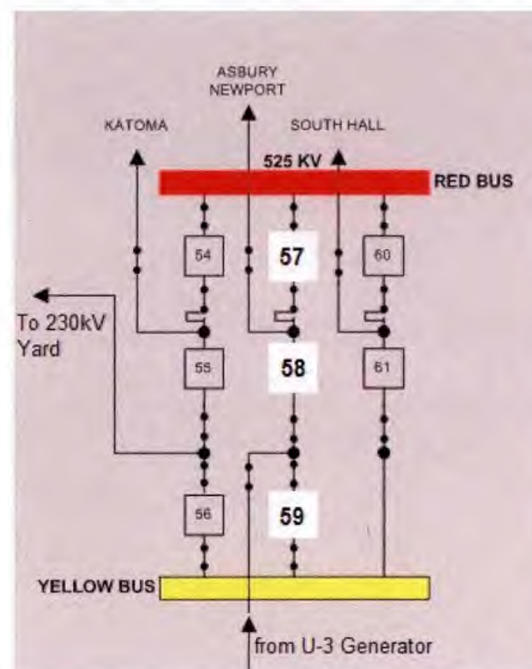
The sketch on the right depicts the 525kV power circuit breaker (PCB) arrangement.

On 7/24/17, with ONS Unit 3 operating at 100% power, Transmission Department Relay personnel in the ONS Switchyard Relay House were performing preventive maintenance on a relay device associated with PCB-57. This is a non-Unit PCB that isolates a commercial transmission line from the Red Bus in the 525kV switchyard.

The maintenance procedure first opens and isolates PCB-57, then triggers the protective relaying while ensuring that the PCB trip function actuates properly. In this case the Transmission crew inadvertently connected the test equipment to the incorrect relay device (several identical relay devices are mounted in one cabinet but actuate separate PCBs). The crew connected test equipment to the adjacent relay device for PCB-58 instead of the relay device for PCB-57. PCB-58 is a Unit breaker that connects the Unit 3 generator output[EL] to the switchyard buses. Activating a test signal on the PCB-58 relay device resulted in Unit 3 generator "lockout" and a loss of electrical load by tripping open PCB-58 and PCB-59. The lockout generates a turbine trip which in turn trips the reactor via the Reactor Protection System (RPS)[JC].
